How one handheld radio ripped a ship's bridge apart

The National Transportation Safety Board (NTSB) in the US has issued its report into the blaze on the bridge (pictured) of the crude tanker S-Trust 12 months ago. Investigators determined that the probable cause of the fire was the thermal runaway of one of the cells in a lithium-ion battery for a UHF handheld radio.

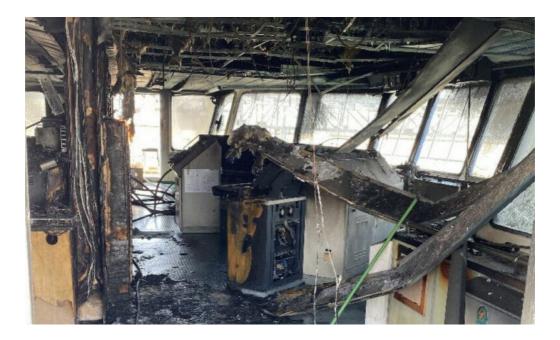
The S-Trust carried 20 ultra-high frequency (UHF) handheld radios for the crew to use to communicate during vessel operations. The two radios assigned to the bridge were a Motorola DP4400e radio (pictured), which used a lithium-ion battery, and a Motorola GP328 radio, which used a nickel-metal hydride battery.

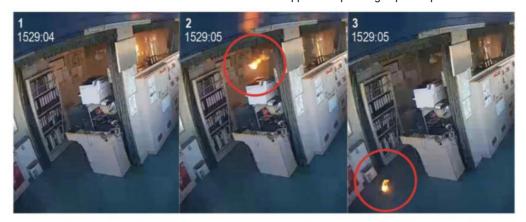
As the fire expanded, the closed-circuit video captured a second flash, followed by a flaming object being propelled from the fire and landing on the deck of the bridge, where it continued to burn. This was most likely the other missing lithium-ion cell from the same battery. Based on the video, investigators determined that the second missing lithium-ion cell also experienced a thermal runaway, most likely initiated from the heat of the fire started by the initial battery cell thermal runaway.

Photos from the bridge closed-circuit camera showing (1) a second explosion, (2) an object on fire propelled into the air (circled in red), and (3) the object, still on fire, landing on the floor (circled in red). (Background source: Stalwart Management Ltd)

Crews can help prevent thermal runaways and ensuing fires, according to the NTSB, by following manufacturers' instructions for the care and maintenance of lithium-ion batteries; properly disposing of damaged batteries; avoiding unsupervised charging; and keeping batteries and chargers away from heat sources and flammable materials.

Should a lithium-ion battery fire occur, crews can attempt to extinguish the fire with water, foam, CO2, or other dry chemical or powdered agents. However, if the battery fire cannot be extinguished, personnel should attempt to allow the pack to burn in a controlled manner; this includes watching for nearby cells that may also experience thermal runaway and extinguishing other combustibles that may catch on fire.
